# Cyanobacteria Monitoring Report 2023

Connecticut River  
Conservancy

# 2023 Report

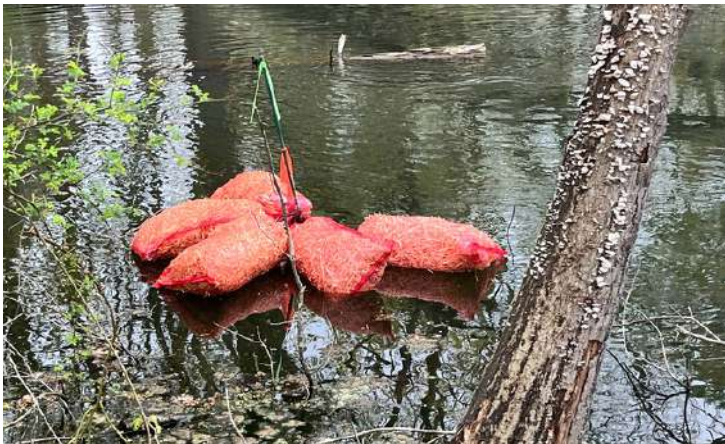
**Fig.1 |** Barley straw bags in Nashawannuck Pond, made with onion bags and recycled bottles for floatation.

Barley straw bags (fig.1) are installed in affected ponds early in the year, before the appearance of algae. Barley was first deployed in 2022; HABs were not observed in treated ponds that year. In April 2023, approximately 170 bags of barley straw were deployed in two Massachusetts water bodies affected by HABs; again, HABs were not observed in treated ponds that year. Bags are collected in the fall.

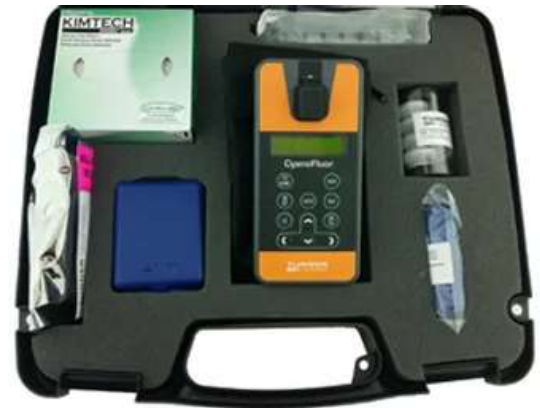
**Fig.2 |** CyanoFluor HAB Indicator Kit.

Thanks to the US Fish and Wildlife Services Silvio O. Conte Refuge, our group was able to acquire the CyanoFluor HAB indicator (fig.2). This device allows us to test ponds for cyanobacteria blooms and get results, within 30 seconds<sup>4</sup>.

The CyanoFluor HAB Indicator is a field-portable fluorometer that measures the abundance of cyanobacteria in a mixed algal population using phycocyanin (PC) to chlorophyll (CHL) ratios. Just like chlorophyll is the pigment that allows plants to photosynthesize, phycocyanin is what allows cyanobacteria to photosynthesize<sup>6</sup>.

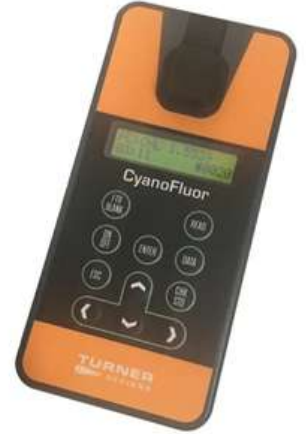
Cyanobacteria is naturally present everywhere<sup>7</sup>, and therefore the device will always detect its presence. When it detects a higher count of PC than CHL (ratio is more than 1), it signifies that the water body in question is experiencing an active cyanobacteria bloom.

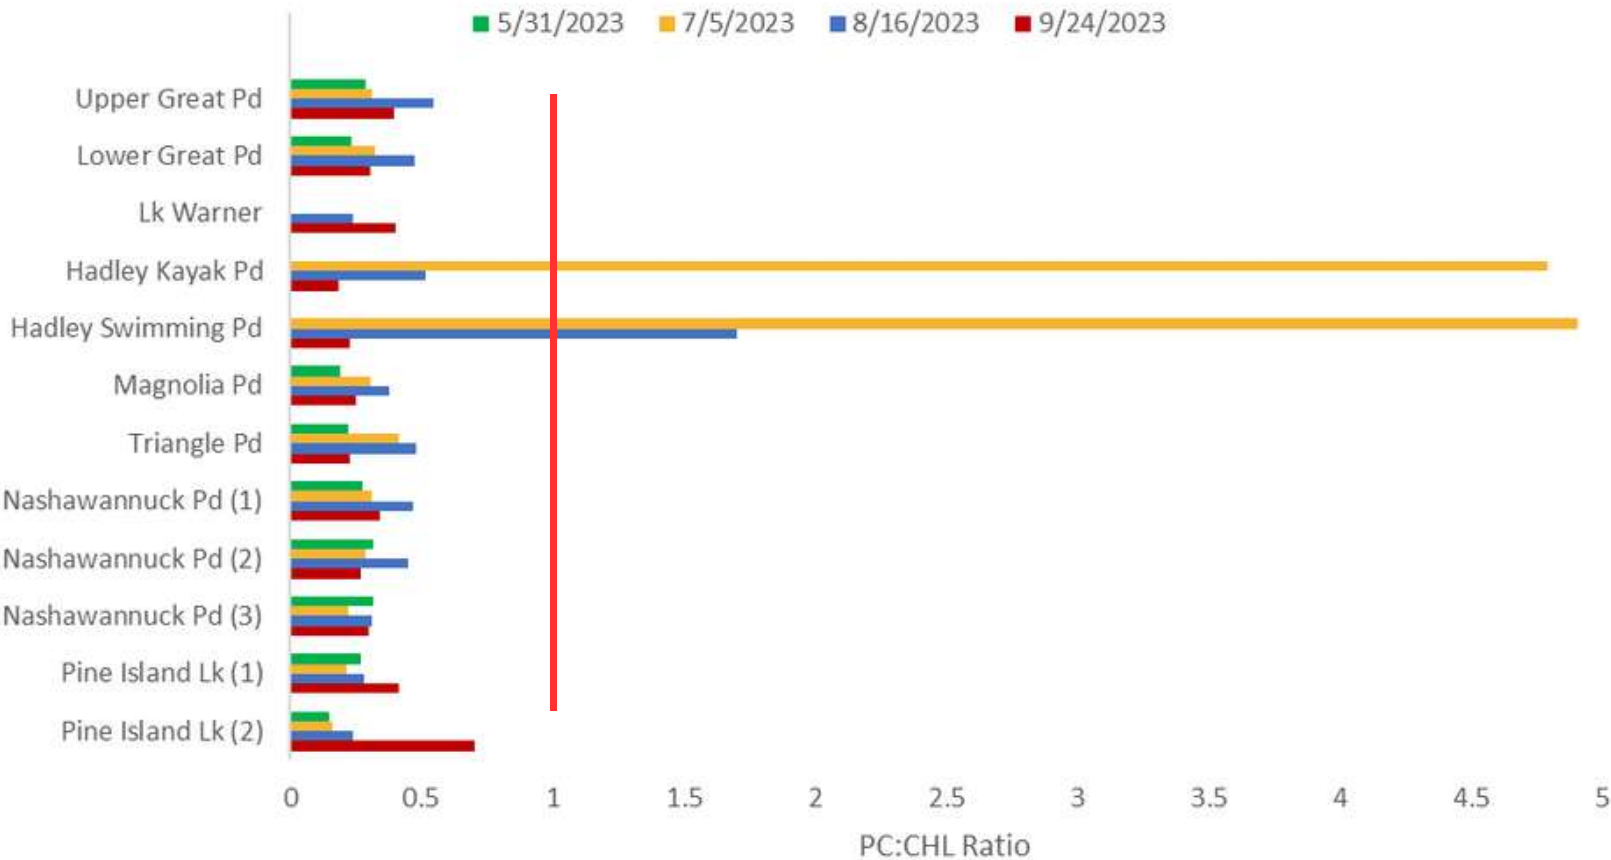
Results below compare all sites tested in 2023. The **red line** indicates the threshold of a cyanobacteria bloom; all samples tested higher than that threshold (ratio > 1) are considered in active bloom.

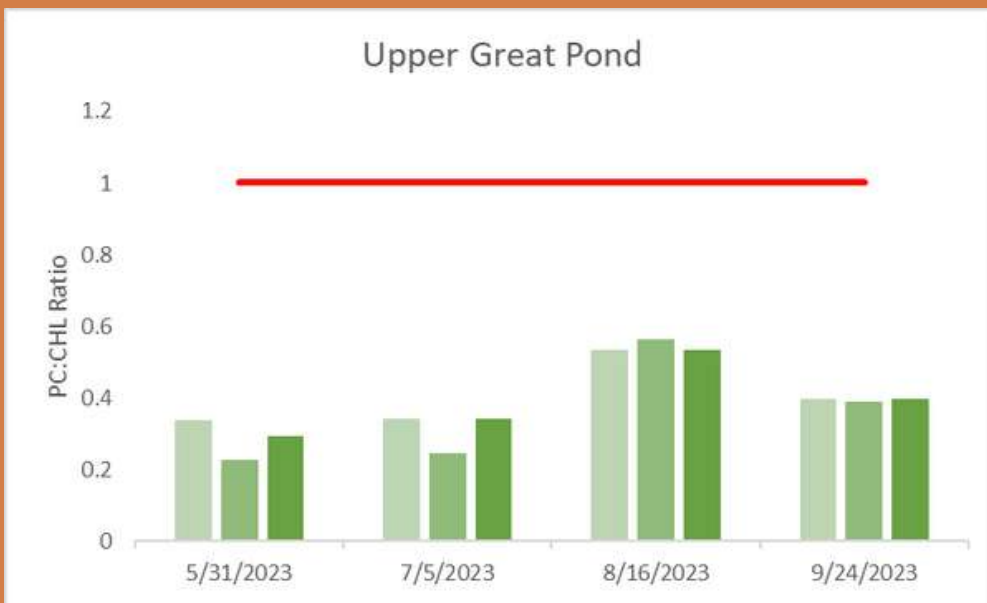
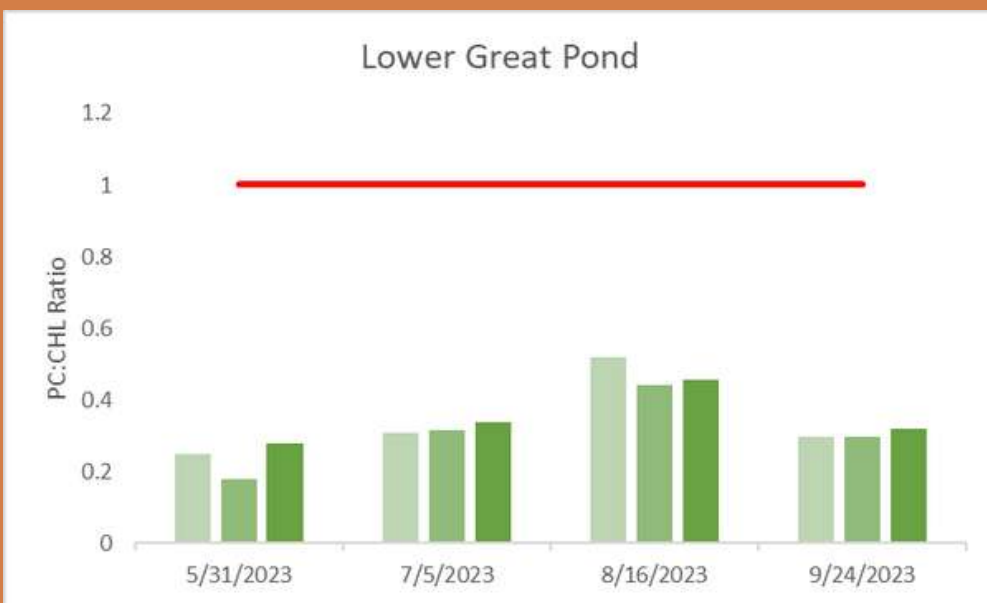
The results below represent the PC to CHL ratio at both ponds throughout the summer of 2023. The **red line** indicates the threshold of a cyanobacteria bloom; samples that test higher than that threshold (ratio > 1) are considered in active bloom. Great Pond did not test positive for cyanobacteria blooms during our monitoring efforts, though it is still possible a bloom occurred outside of our sampling days.

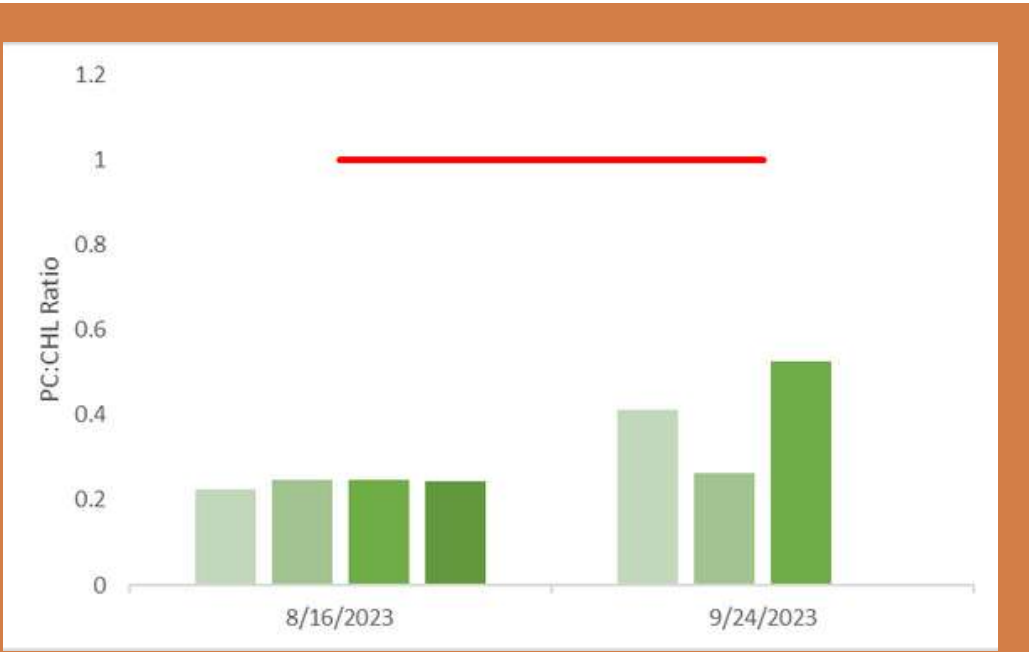
The results below represent the PC to CHL ratio at Lake Warner during the monitoring efforts of 2023. The **red line** indicates the threshold of a cyanobacteria bloom; samples that test higher than that threshold (ratio > 1) are considered in active bloom. Lake Warner did not test positive for cyanobacteria blooms during our monitoring efforts, though it is still possible a bloom occurred outside of our sampling days.

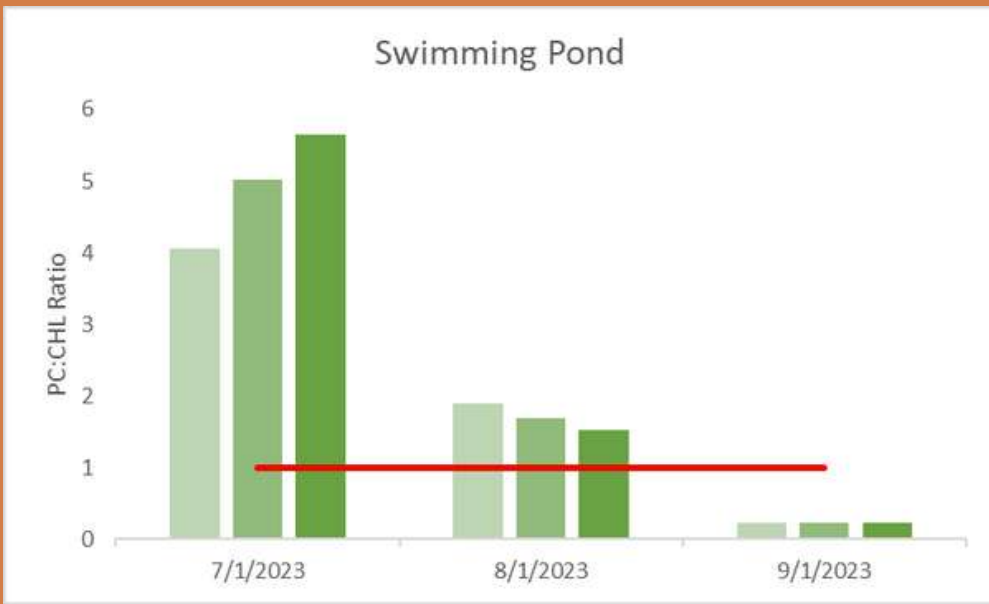
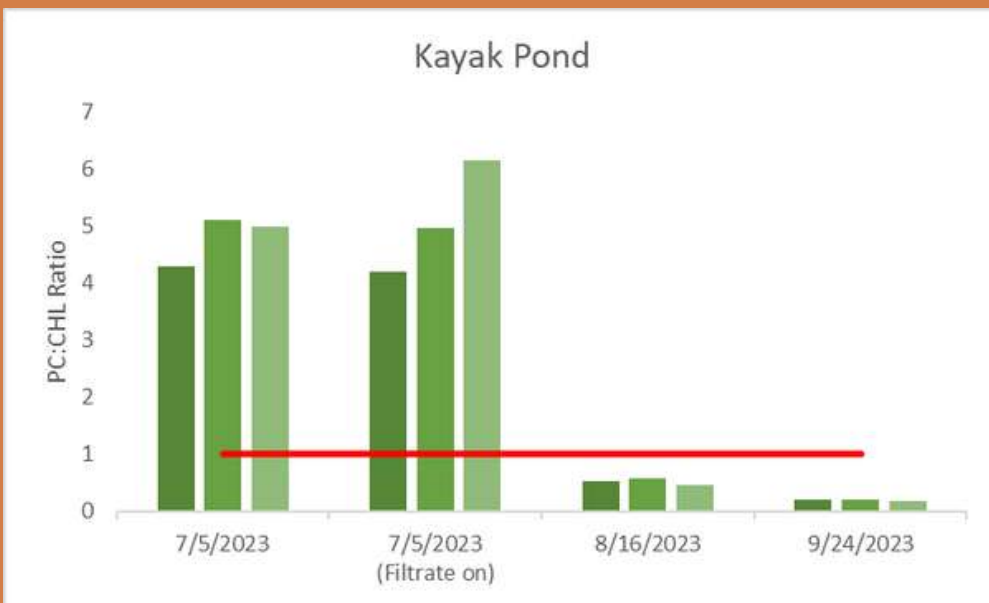
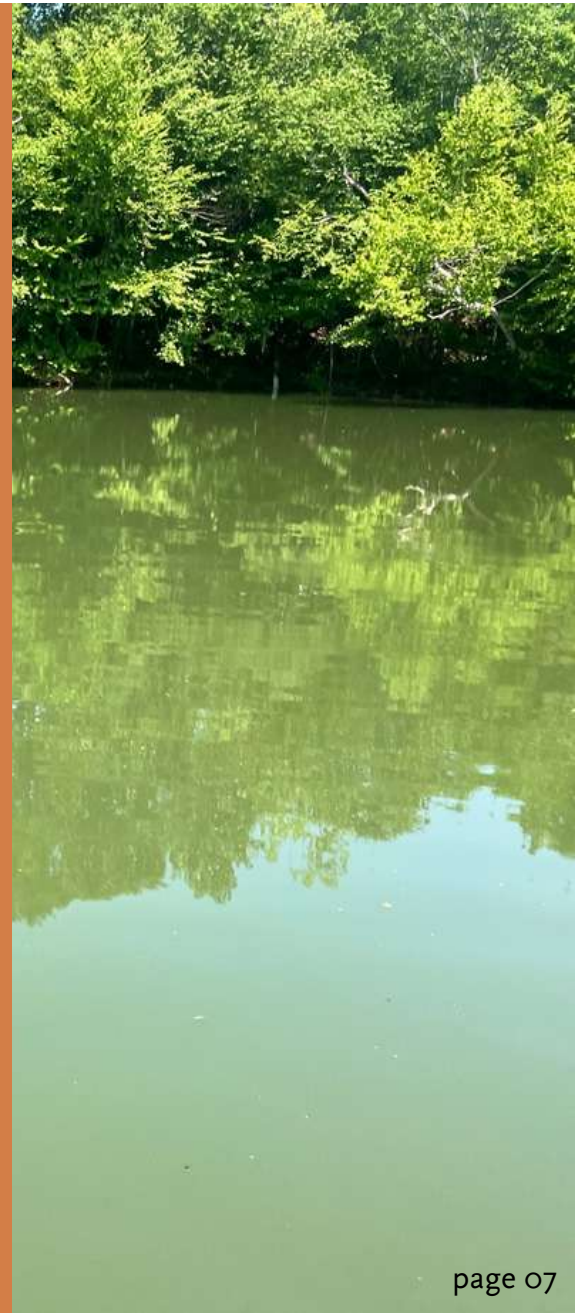
The results below represent the PC to CHL ratio at the two ponds during the monitoring efforts of 2023. The **red line** indicates the threshold of a cyanobacteria bloom; samples that test higher than that threshold (ratio > 1) are considered in active bloom. The ponds tested positive for cyanobacteria blooms. A second test was conducted in July on the “Kayak” Pond, using filtered sample water to test without dissolved organic matters which can affect the results. The landowners were informed and were advised to not use the ponds until further tests are done or the opaque green coloration on the ponds as seen in the picture dissipate.

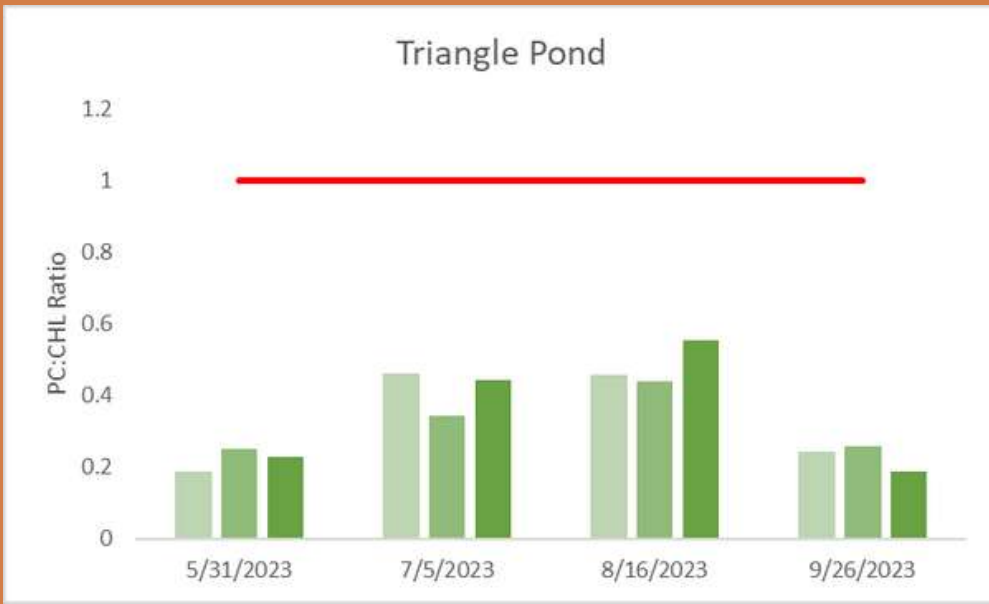
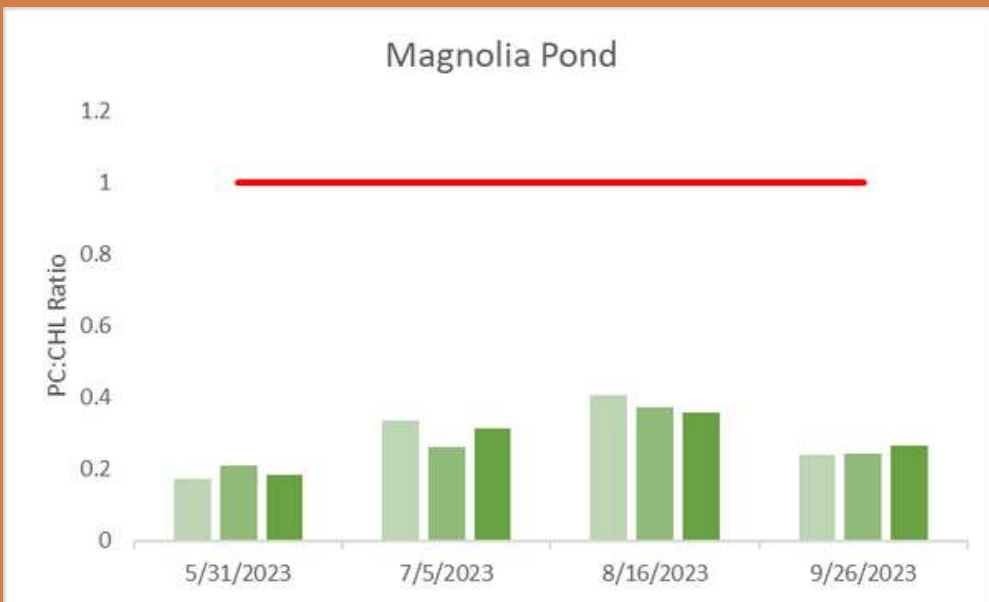
The results below represent the PC to CHL ratio at the two ponds during the monitoring efforts of 2023. The **red line** indicates the threshold of a cyanobacteria bloom; samples that test higher than that threshold (ratio > 1) are considered in active bloom. Triangle and Magnolia Ponds did not test positive for cyanobacteria blooms during our monitoring efforts, though it is still possible a bloom occurred outside of our sampling days.

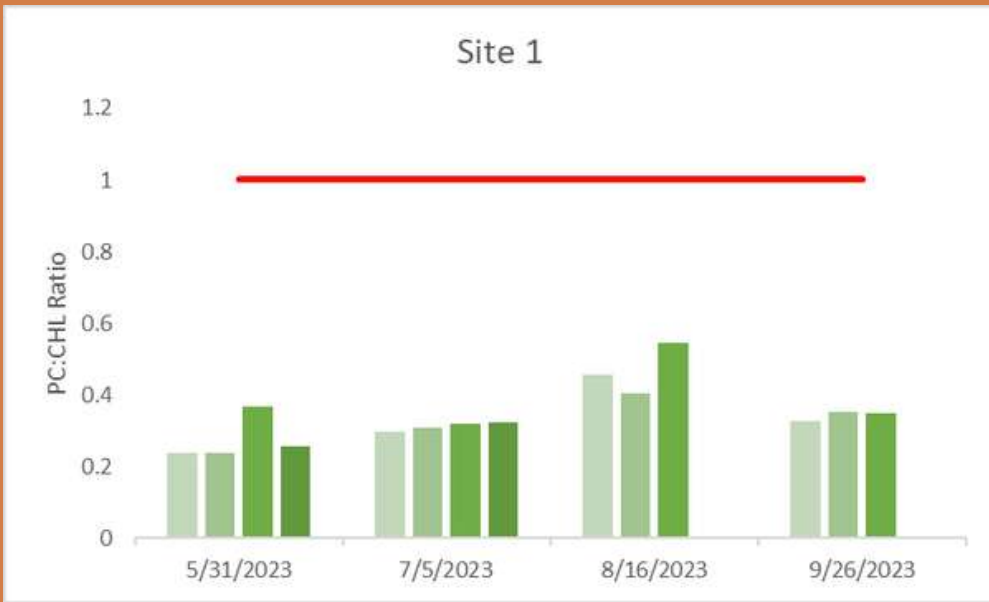
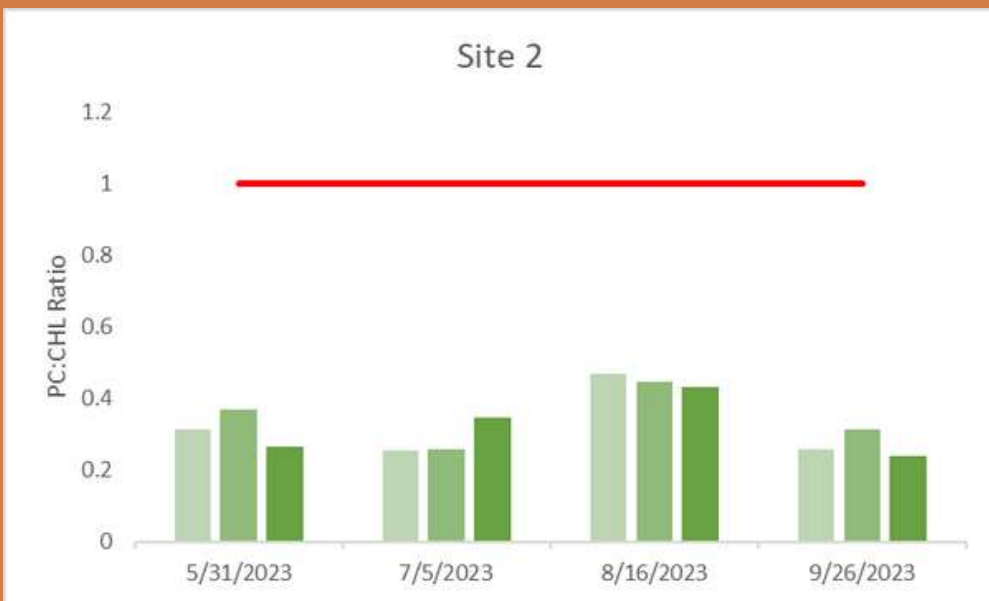
The results below represent the PC to CHL ratio at 3 sites on Nashawannuck Pond during the monitoring efforts of 2023. The **red line** indicates the threshold of a cyanobacteria bloom; samples that test higher than that threshold (ratio > 1) are considered in active bloom. Nashawannuck Pond did not test positive for cyanobacteria blooms during our monitoring efforts, though it is still possible a bloom occurred outside of our sampling days.

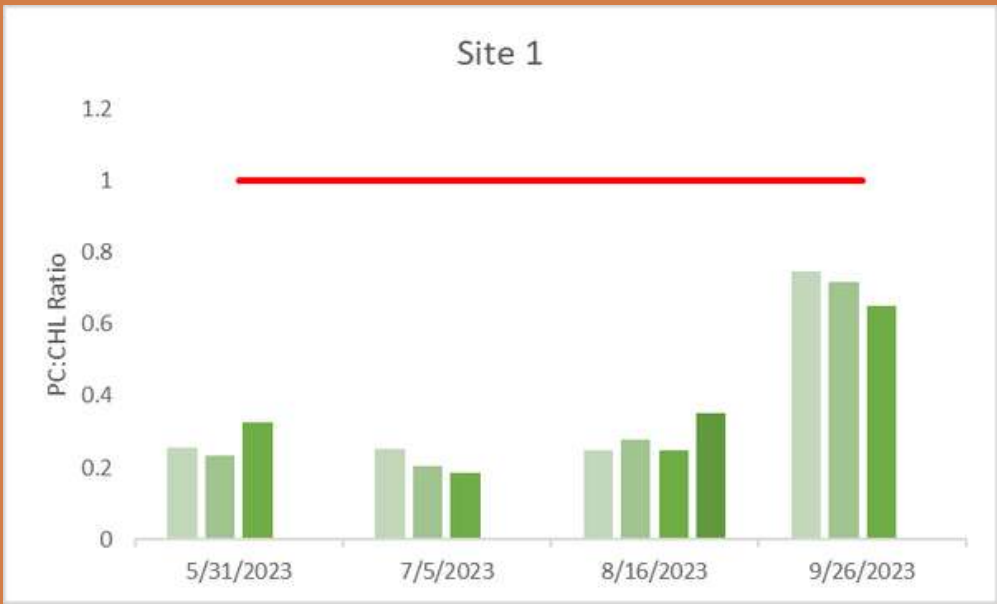
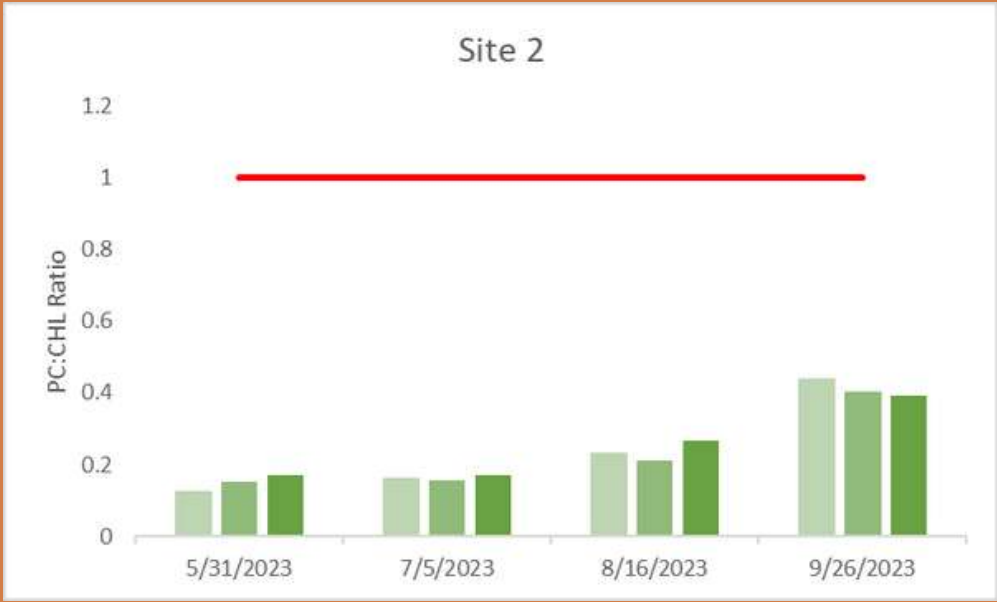
The results below represent the PC to CHL ratio at 2 sites on Pine Island Lake during the monitoring efforts of 2023. The **red line** indicates the threshold of a cyanobacteria bloom; samples that test higher than that threshold (ratio > 1) are considered in active bloom. Pine Island Lake did not test positive for cyanobacteria blooms during our monitoring efforts, though it is still possible a bloom occurred outside of our sampling days.
