Connecticut River Conservancy

February 26, 2025

Re: Bellows Falls Hydroelectric Project (FERC No. 1855) draft 401 Water Quality Certification
(ENB ID: PN24.0018903)

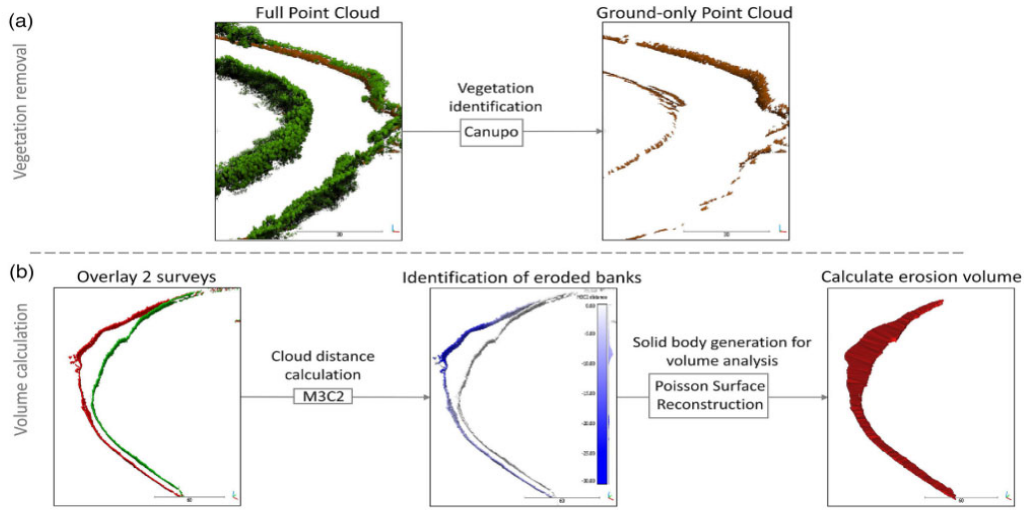
FIGURE 2 Schematic overview of the data processing workflow. Note that the bank segment shown in figure (a) (vegetation removal) differs from the bank segment shown in figure (b) (volume calculation) because areas with considerable bank erosion are generally near-vertical banks without vegetation cover—thus, different segments are best used to illustrate the two steps. [Color figure can be viewed at wileyonlinelibrary.com]

Figure 2 Illustration of the ability of the use of LiDAR to accurately assess vegetation cover and slope/volume changes of riverbanks.

- Due to the advancement and cost efficiency of LiDAR technologies for use in the monitoring of rivers and bank stability, obtaining riverbank topographic data and vegetative cover, even over an impoundment as long as one behind the Bellows Falls Dam, is strongly recommended. Such data to be collected will be an initial baseline flyover via drone or helicopter survey to collect the above and below water surface slope conditions pre-change to IEO. Such data can be used to identify existing slope movements and vegetative covers. In subsequent years, say biannually, or after significant events such as flooding caused by tropical storms, nor'easters, or summer catastrophic storms such as have occurred over Vermont in the last two years a flyover LiDAR (upland and bathymetry) survey must be conducted. Subsequent years can be precisely overlain over prior years to calculated changes in slope elevations. Especially following significant flooding, the impacts between regional storm events versus bank instability caused by operations can be distinguished. In consulting with remote sensing/survey firms who conduct such services, each survey, including analysis and reporting can be completed for less than \$50,000 in 2025 dollars, proving VT DEC and the public with a more comprehensive, quantitative assessment of the stability of the riverbanks and the vegetative cover that adds to river stability. Such a cost would be comparable, if not less costly than ground surveying the limited number of river sections previously completed to determine the overall stability of slopes within the subject impoundment. The surveys conducted would then be overlain with the HEC-RAS 2-dimensional models to evaluate natural and operational flows and how they may be contributing to riverbank instability. The following figures illustrate the usefulness of this technology and how it has been researched and developed for a situation such as for the Bellows Falls Dam impoundment reach.

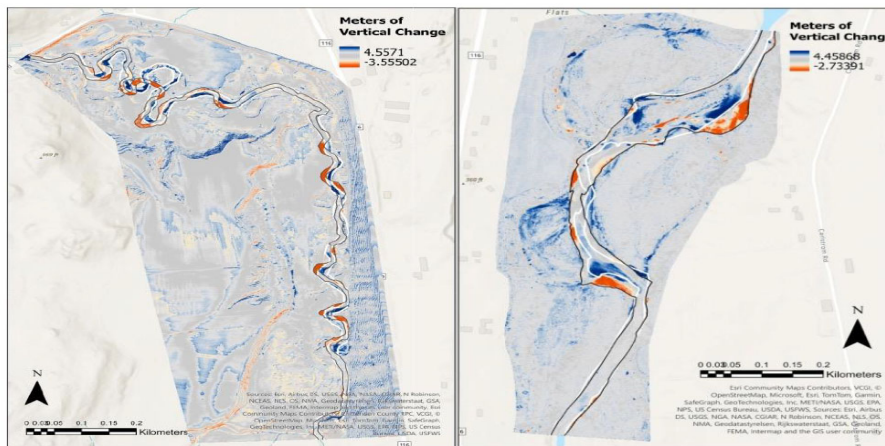
Fig 3. The Lewis Creek DoD (left) and New Haven River DoD (right). The black outline represents the 2023 stream channel boundary, and the white outline shows the older channel boundary. Polygons representing the extent of bank erosion were drawn in between the channel boundaries where the new channel was outside the older channel.

Figure 1 Another illustration of the ability of the use of LiDAR to accurately assess vegetation cover and slope/volume changes of riverbanks.

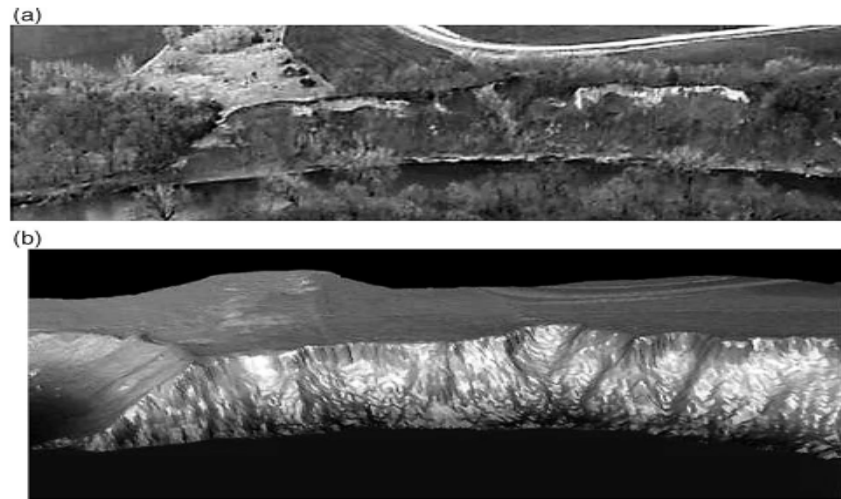
Fig. 2. (a) A severely eroded site along the Blue Earth River photographed at an oblique viewing angle from the air, and (b) rendered as a bare-earth elevation model from the LIDAR data. Vegetation was filtered and points gridded to a 1 m interval in the LIDAR image to create the model. Note gravel road passing through fallow field for scale in both figures.

Figure 3 The use of LiDAR from oblique angles to evaluate the overall stability and areas of failures on riverbanks.

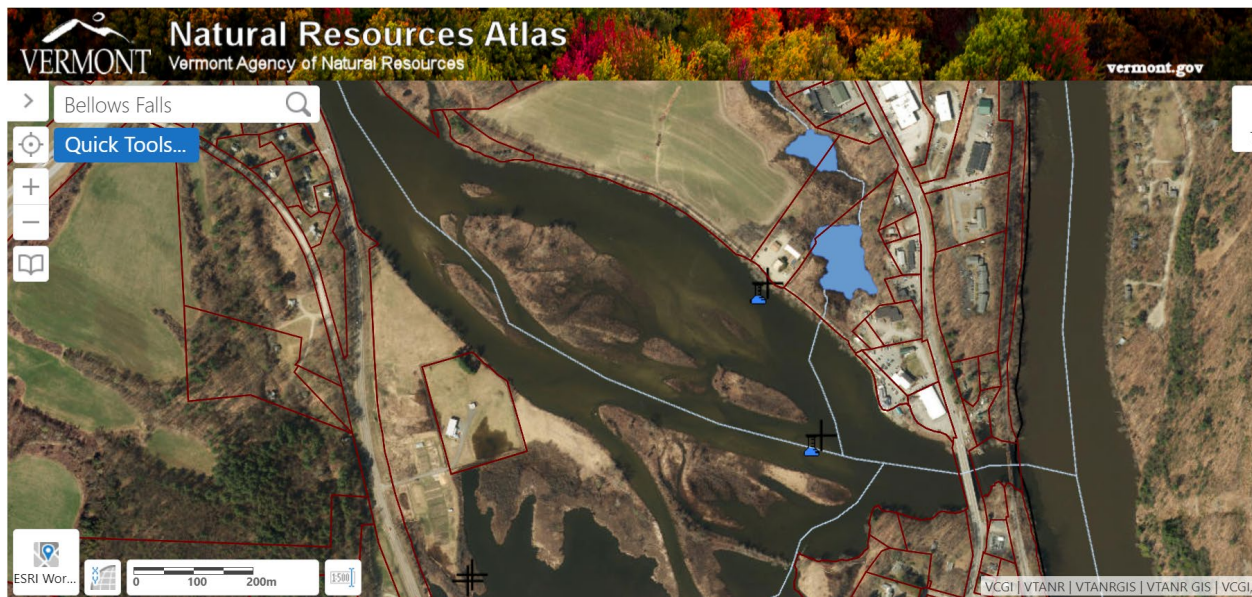
Figure 1: West River confluence with the Connecticut River. ANR Natural Resources Atlas

Because of many decades of peaking operations, the Wilder, Bellows Falls, and Vernon impoundments have been functioning essentially as lakes, with long stretches of low flows during much of the day. Consequently, tributaries that empty into each of those impoundments have a sediment wedge at the confluence of the Connecticut River. This is clearly visible on the Vermont Agency of Natural Resources (“ANR”) Atlas, such as the example in Figure 1 from the West River.

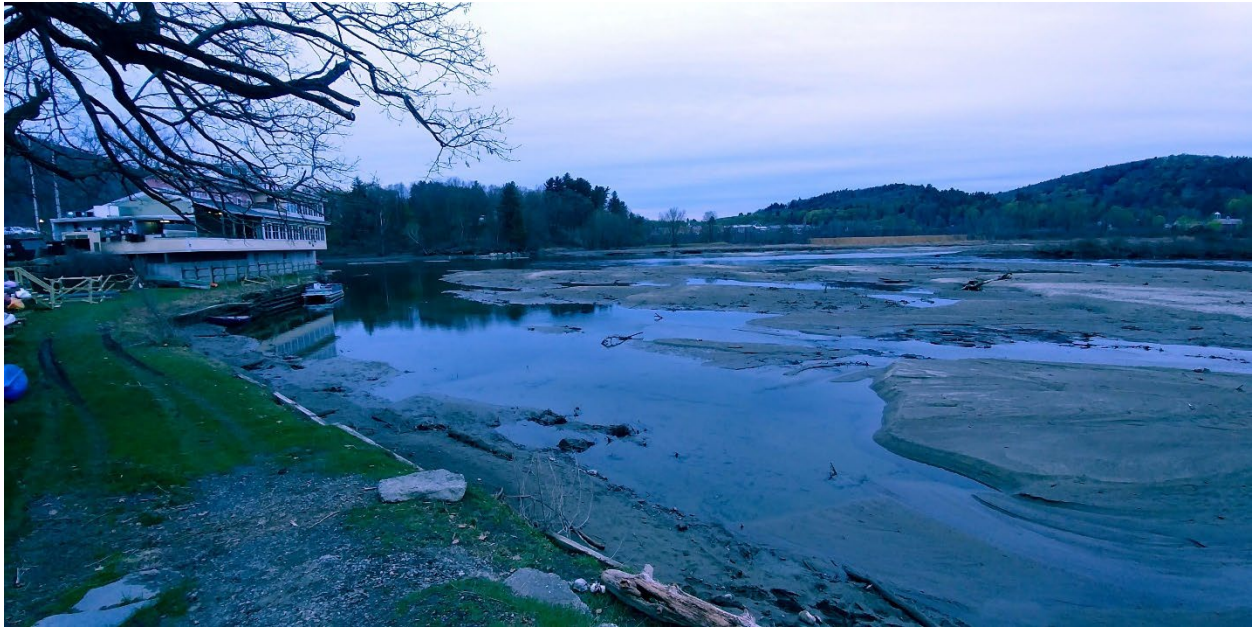
the Vernon impoundment, that shows the excessive, unnatural sediment buildup at this confluence.

Sediment deposition: View from 42.868306, -72.558639, facing south across the West River. Taken by Kathy Urffer on May 1, 2019.

CRC staff have personal experience attempting to recreate at this location in Brattleboro and can attest to sediment buildup at the mouth of the West River that reaches up to 1.3 miles upstream. The sediment load is so high, that when GRH is moving water through the Vernon facility and reducing the surface water level of the Vernon impoundment, it can be too shallow to boat in this area. Additionally, below is an image, taken on May 1, 2019, during a drawdown of

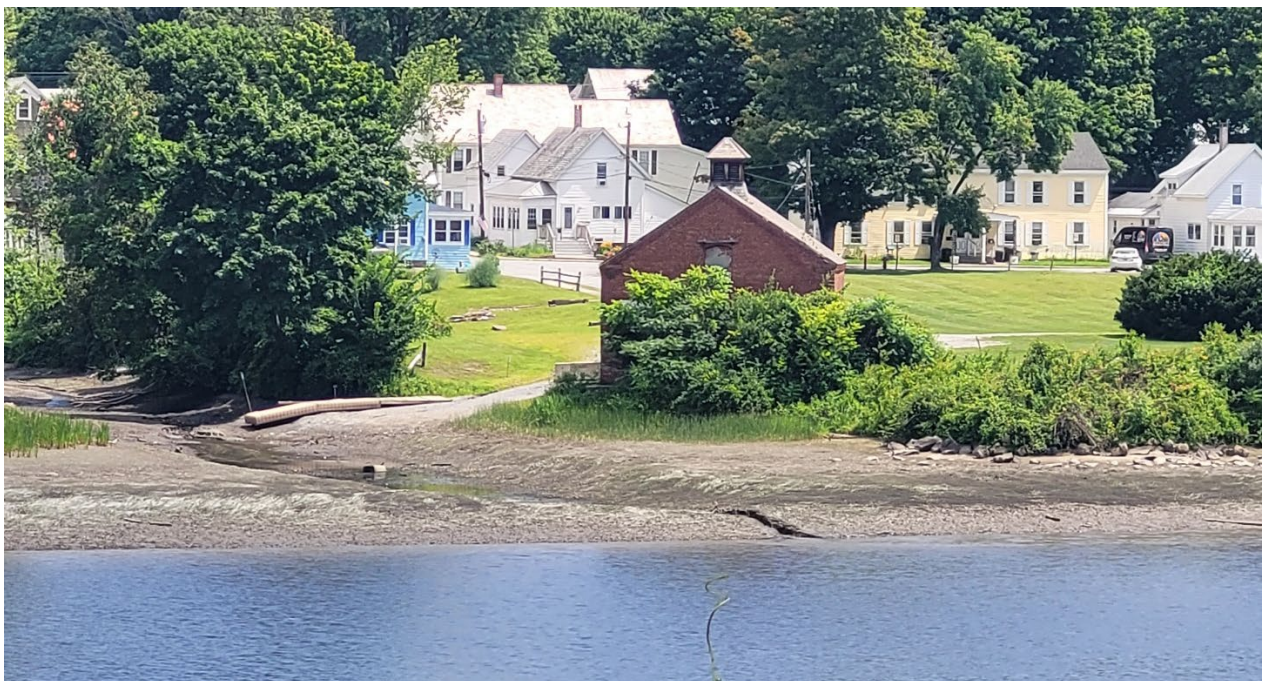
And similar sediment build-up can be seen in this photo of the confluence of an unnamed brook adjacent to the Bellows Falls Pine Street Portage take-out in the Bellows Falls impoundment:

Sediment deposition: View from 43.142000, -72.454889, facing east across the Connecticut River. Taken by Kathy Urffer on August 2, 2023.

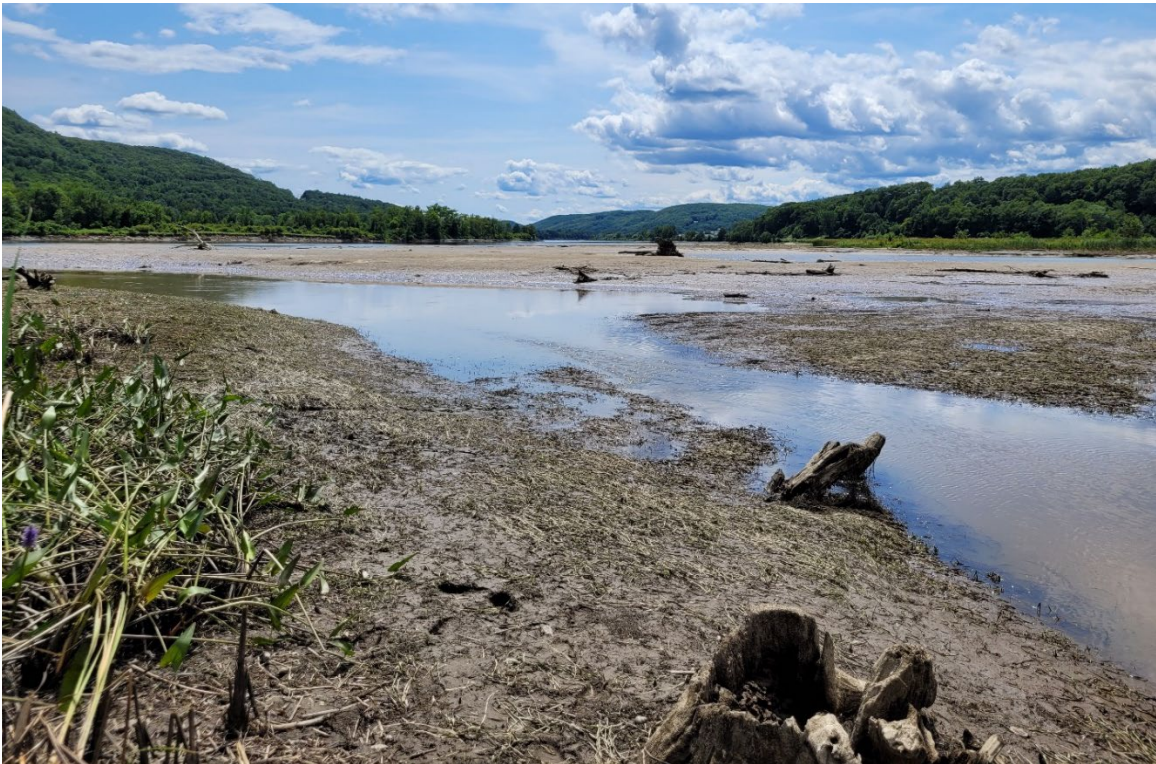
Dewatered wetlands at Herrick’s Cove: View from 43.176400, -72.448400, facing southwest across the Williams River backwater area. Taken by Kathy Urffer on August 2, 2023.

The email goes on to indicate that “visitors to Connecticut River will see exposed riparian areas upstream of Bellows Falls dam, most visible closest to the Bellows Falls dam.”²³ CRC staff visited the backwater areas of Herrick’s Cove during the drawdown and documented aquatic species that were killed by desiccation because of this event.

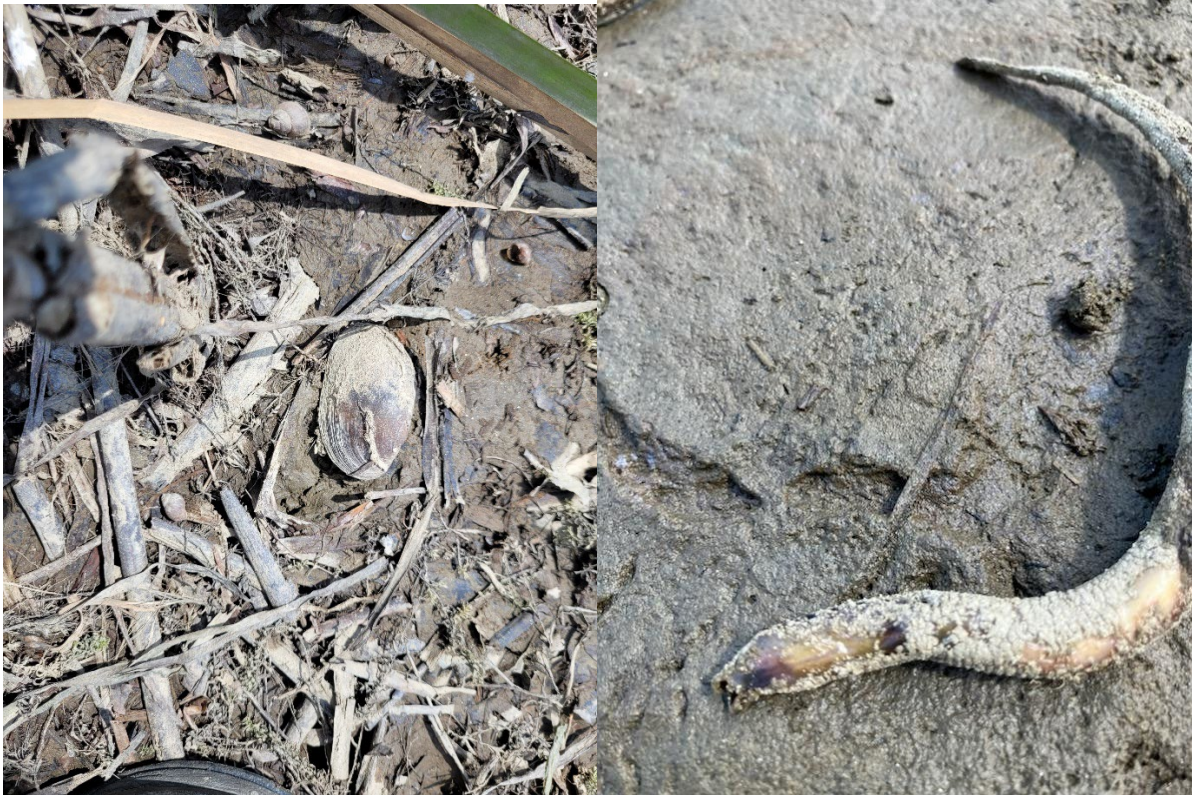
Desiccated mussel, snail, and sea lamprey at Herrick's Cove: View from 43.176400, -72.448400, facing southwest across the Williams River backwater area. Taken by Kathy Urffer on August 2, 2023.

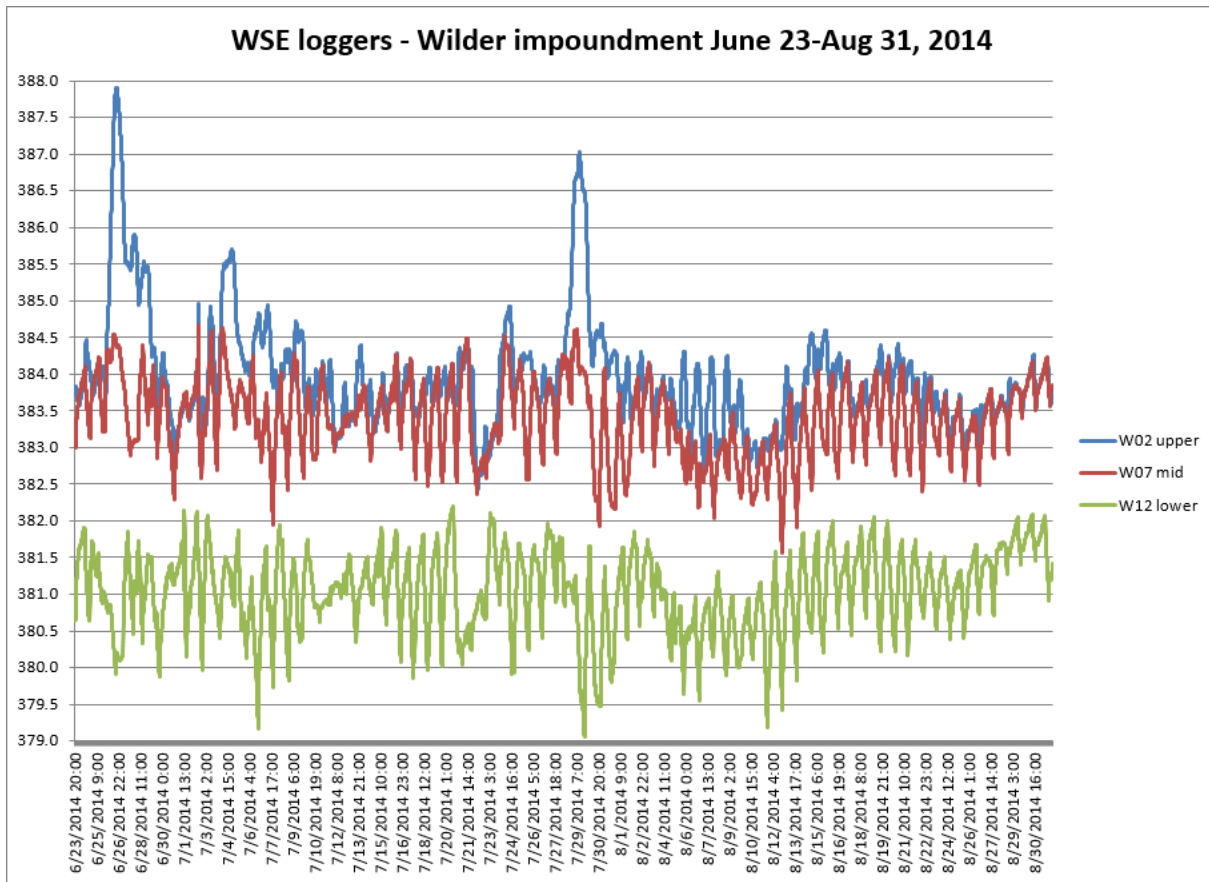
Figure 1: Water Surface Elevation as measured in the lower, middle, and upper Wilder impoundment in 2014, demonstrating peaking frequency as well as the higher water level and greater magnitude of fluctuation in relation to distance upstream from the dam.

Given the specific influence of peaking flows from the Fifteen Miles Falls projects that impact the upper end of Wilder impoundment, and the lack of analysis in regard to the preferred operation under the new license, GRH must be required to support an ongoing multi-decade monitoring program to assess any ongoing potential impacts of changes in operation on the banks of the Wilder impoundment and in changes in sediment deposition throughout the project area, and subsequently take responsibility for mitigation required to address those impacts.

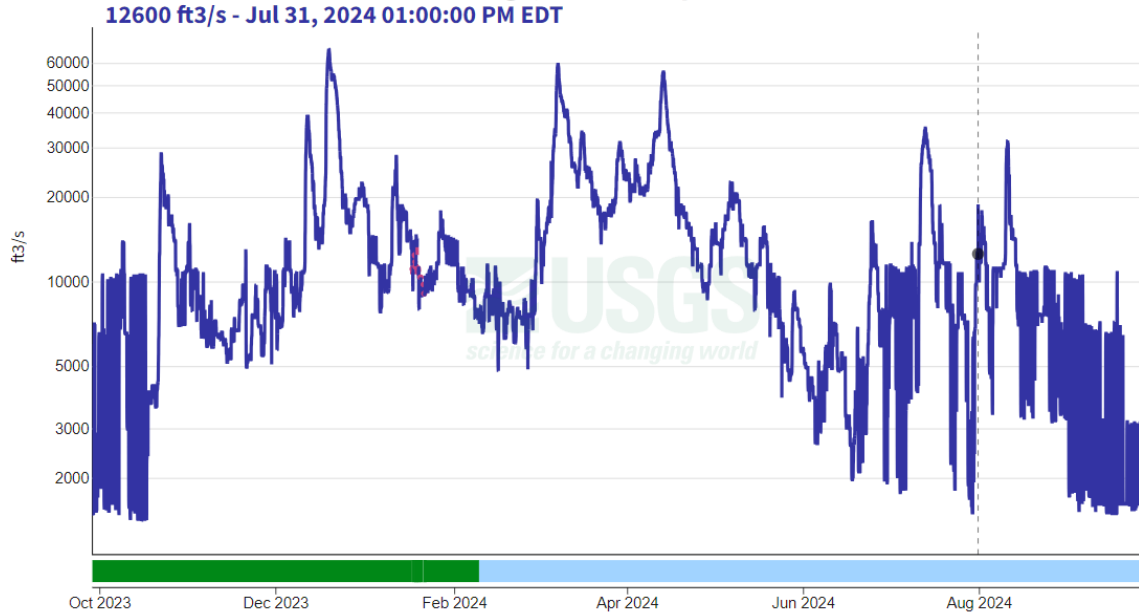
USGS Stream gage cfs flows at North Walpole: September 29, 2023 to September 27, 2024.

While 2024 may have been a wet year, climate models predict and lived experience confirms that there is more precipitation in winter falling as rain. Vermont is experiencing a consistently reduced snowpack resulting in more water running off the land, and we should expect increases in more intense localized storms throughout our region. Given that, the hydrograph above may more appropriately reflect the future, and we can expect more flows passing into the bypassed reach.

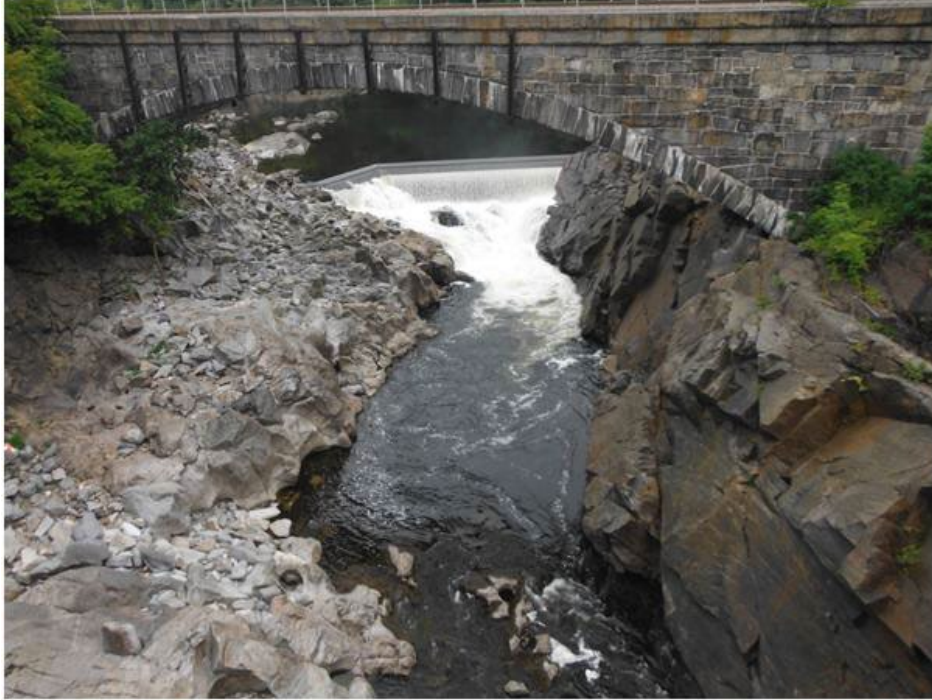
Photo 26⁷¹. Bellows Falls Bypassed Reach showing the Salmon dam; looking upstream right channel toward fish barrier from Vilas Bridge.

Subsequently, it is critical to protect any available habitat in the bypass reach and provide for fish passage. By installing a fish friendly turbine, GRH acknowledges that American eel and other species will be passing downstream into the bypassed reach. The obsolete salmon dam must be removed to provide the free flow of available water and easy passage.

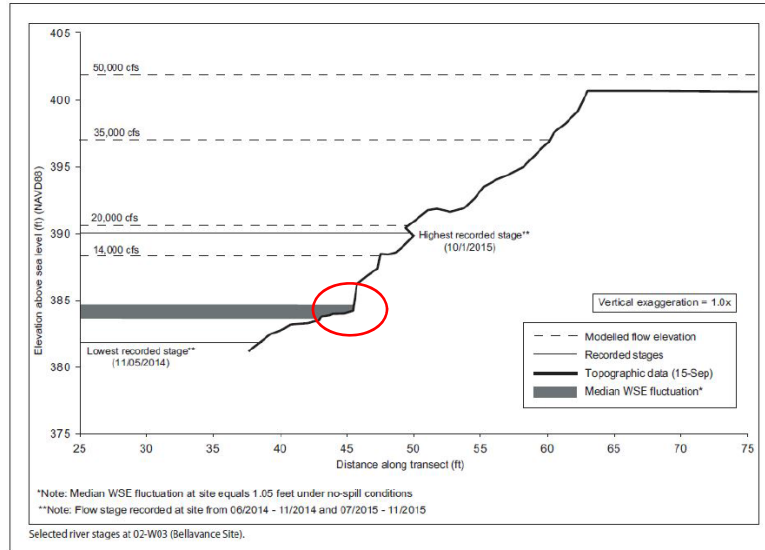
- “Banks composed of non-cohesive sediments and interlayered cohesive and non-cohesive sediments are the most susceptible to erosion.” (page 10, Study 2 and Study 3 Report)
- “Normal project operations result in daily or sub-daily fluctuating water levels. At many sites, the position of those daily fluctuations on the bank aligns with the location of notching at the base of the bank”(page 53, Study 2 and Study 3 Report). Figure 5.4.2-6, below, from the Study 2 and Study 3 Report illustrates this observation, with the location where the WSE fluctuation based on normal operating range intersects with the notch in the river bank, circled in red.

Figure 5.4.2-6. Position on bank of normal operating range aligns with location of notching at 02-W03 (Bellevance Site).

- “Fluctuations in WSE related to normal project operations under no-spill conditions are consistent with notching and overhangs observed at the base of 8 of the 21 monitored banks at some point during the two-year monitoring period (Appendix A). Erosion can result from seepage forces generated by WSE fluctuations (Budhu and Gobin, 1995) with overhangs developing when seepage is focused along a single layer (Fox and Wilson, 2010).” (page 111, Study 2 and Study 3)
- “The character of sediments in the study area creates banks with limited resistance to erosion. The bank sediments at the monitoring sites, representative of the study area as a whole, are nearly ubiquitously comprised of fine-grained and unconsolidated floodplain or glaciogenic sediments particularly prone to erosion (see Appendix A stratigraphic columns). Frequently observed inter-beds of permeable sand and less
